Mobile Intel[®] Celeron[®] Processor at 466 MHz, 433 MHz, 400 MHz, 366 MHz, 333 MHz, 300 MHz, and 266 MHz Specification Update

Release Date: July 2002

Order Number: 244444-034

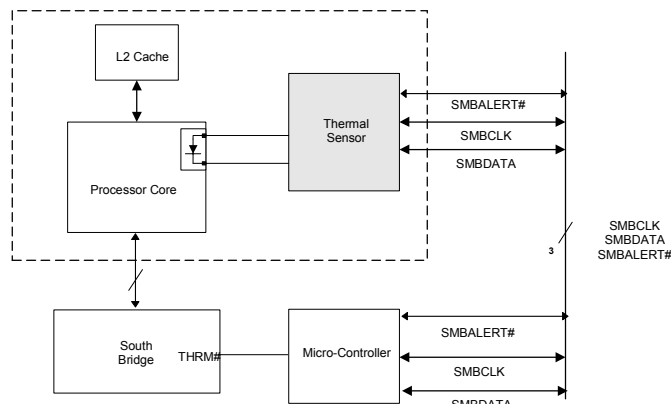
Figure 1. An Example of Microcontroller Driven Thermal Management

H29. Thermal Sensor May Assert SMBALERT# Incorrectly

Problem: The Intel Celeron Processor Mobile Module has a thermal sensor that monitors the processor core's temperature. Please note that desktop systems could have a similar thermal device. The thermal sensor asserts SMBALERT# if the processor temperature exceeds the temperature limits set in the Alarm Threshold Registers (T_{HIGH} , T_{LOW}). It also sets the corresponding Status Register bits to identify the cause of the interrupt. Figure 1 gives one example of the how the SMBALERT# signal could be used in a system.

Implication: There is no system impact from this erratum if temperature polling is used for processor thermal management. If the SMBALERT# interrupt is employed to manage processor thermal sensing, then servicing the false interrupt may result in premature system action depending on the software and hardware implementations used. The rate of the false interrupts is less than the auto-convert rate of the thermal sensor.

Workaround: Three different (mutually exclusive) workarounds are possible:

1. Before servicing an interrupt from the thermal sensor, read and compare the processor thermal reading with the threshold limits (T_{HIGH} or T_{LOW}). Figures 2 and 3 provide basic flowcharts for the implementation of this workaround in an interrupt driven system.
2. If the firmware implemented polls the Status Register only, then before taking any action, re-read the temperature register and do a comparison with the alarm threshold limits (T_{HIGH} or T_{LOW}) to determine if the value is actually still within the temperature window.
3. Use a temperature polling scheme to monitor the processor temperature.
